Navajo Abandoned Uranium Mine

Site Screen Report

Mine Name: Harvey Blackwater No. 4
Mine ID: 240

April 2012

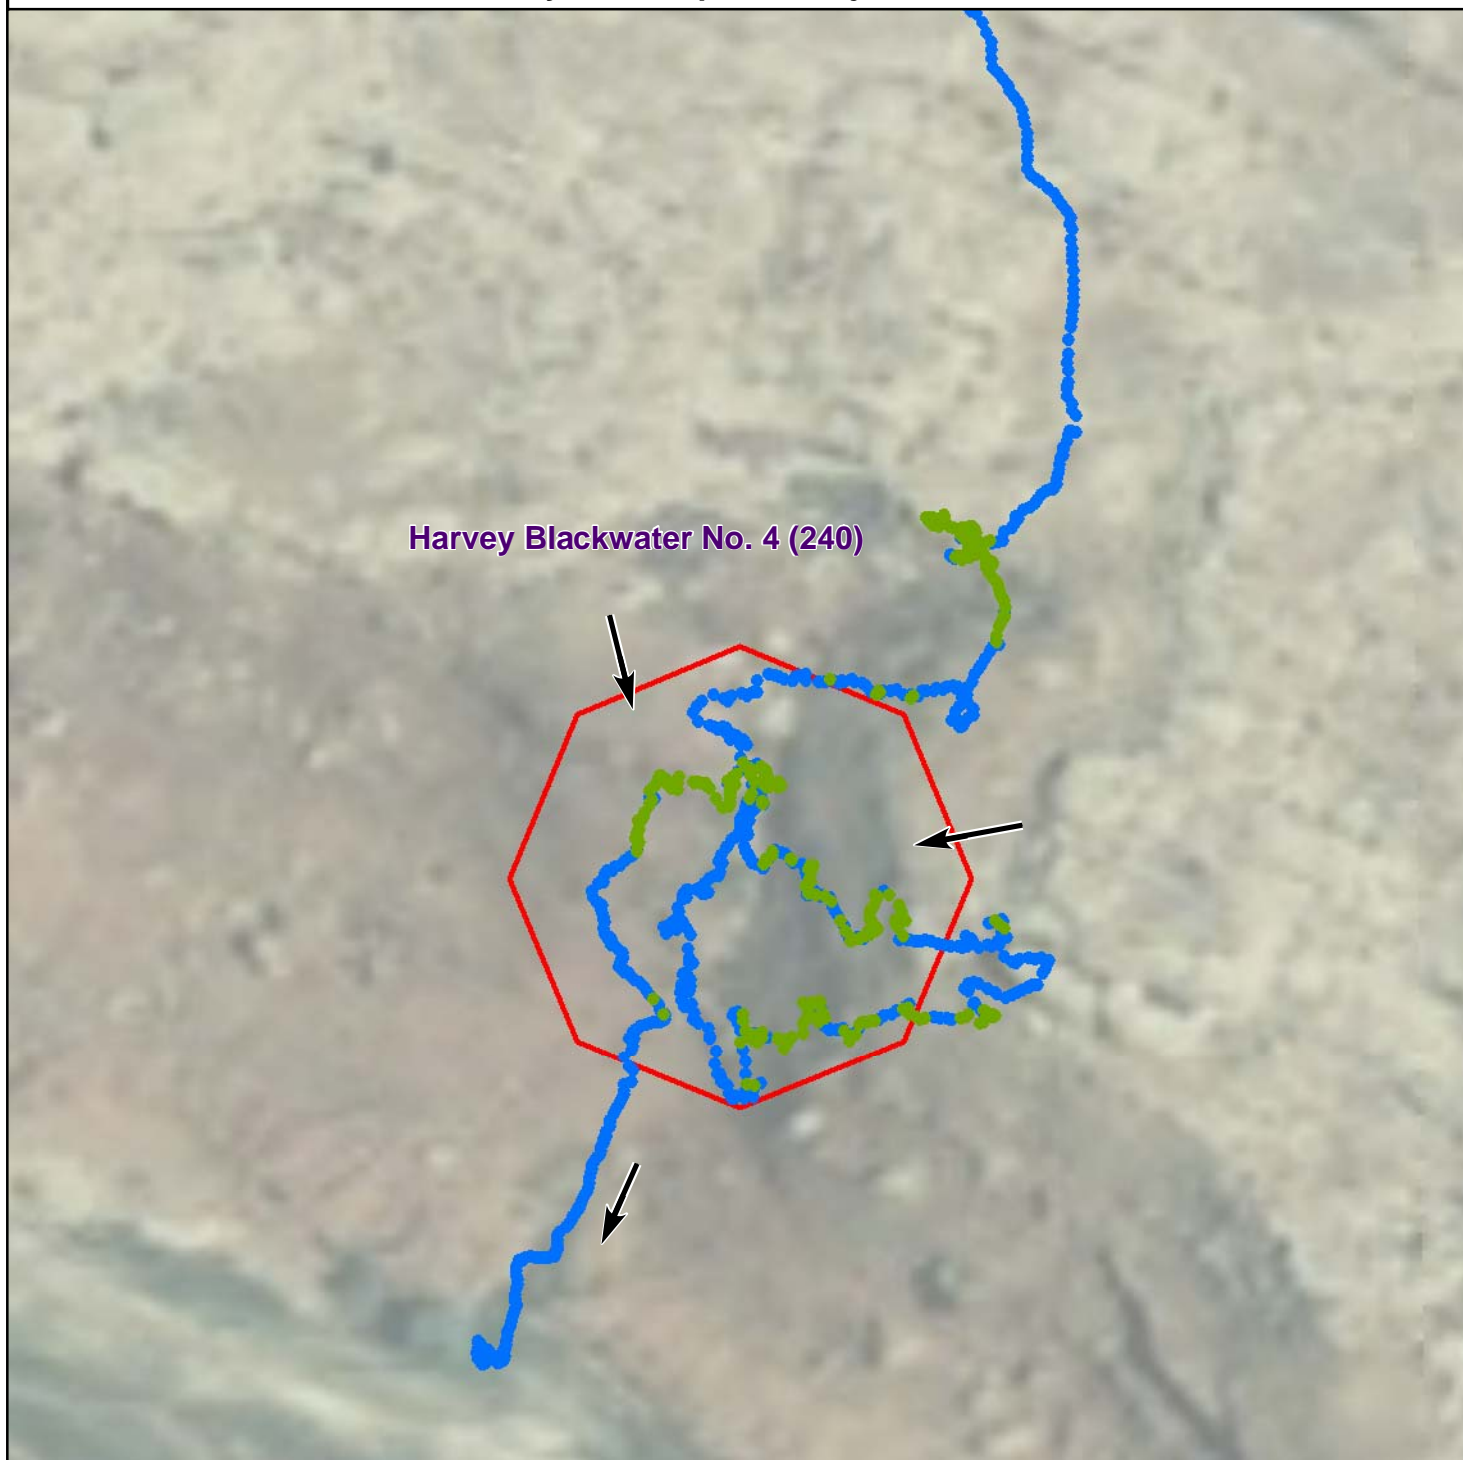
Figure 2 - Gamma Radiation Measurements
Harvey Blackwater No. 4 (240)
Kayenta Chapter, Navajo Nation

A total of 1,472 gamma radiation measurements were collected from the mine site, ranging from 4,083 cpm to 23,604 cpm. The measurements are represented in Figures 1 and 2.

Average background 7,002 cpm
